CP-10: TIGHT PISTONS

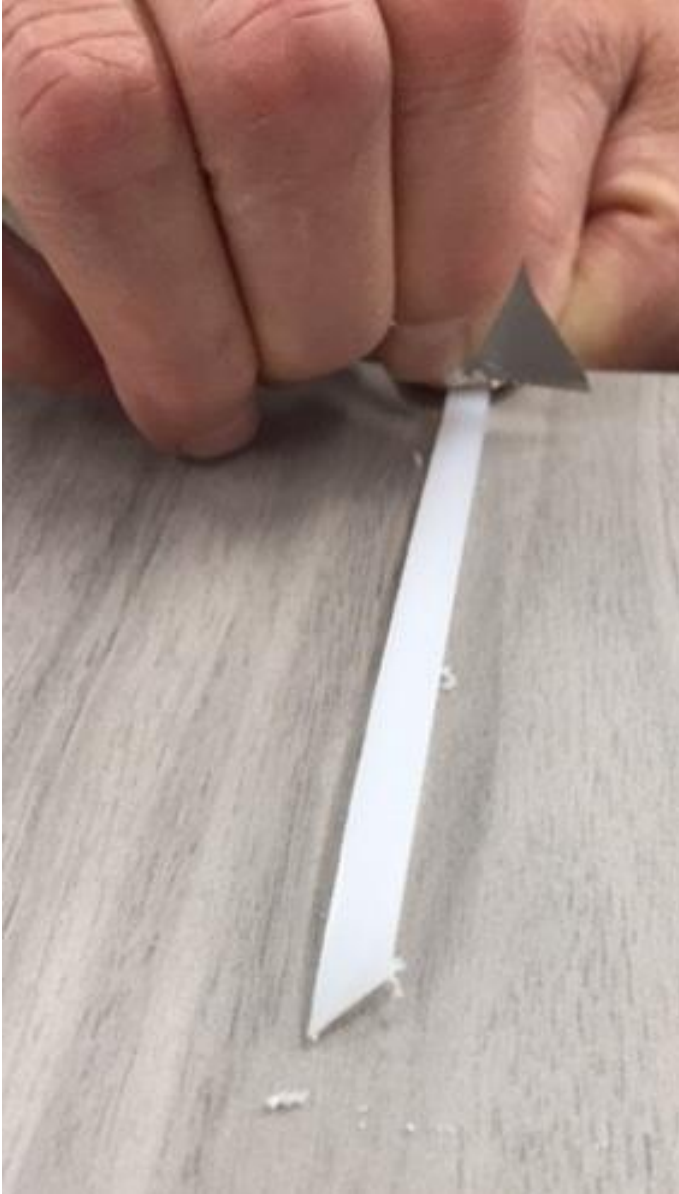
If the piston is not showing any signs of rubbing then the piston bushings (the flat white split rings) are causing the issue. You can reduce the thickness of these bushings by holding them as shown and scraping them with a razor blade (as show in the photo below). Hold the razor blade perpendicular to the surface of the bushing and push it away from you. This scraping motion will pull off a thin layer of plastic each time you do it, you are not trying to cut the material but scrap it. You can see the small chips that

have been scrapped off. Do this about 10 times on each edge and then reassemble the pump.

Note: if you mark the surface of the bushing with a felt tip marker pen then you will be able to see exactly where you are removing material. It looks a little crude but it does work.
