CP-11 CHECK VALVES

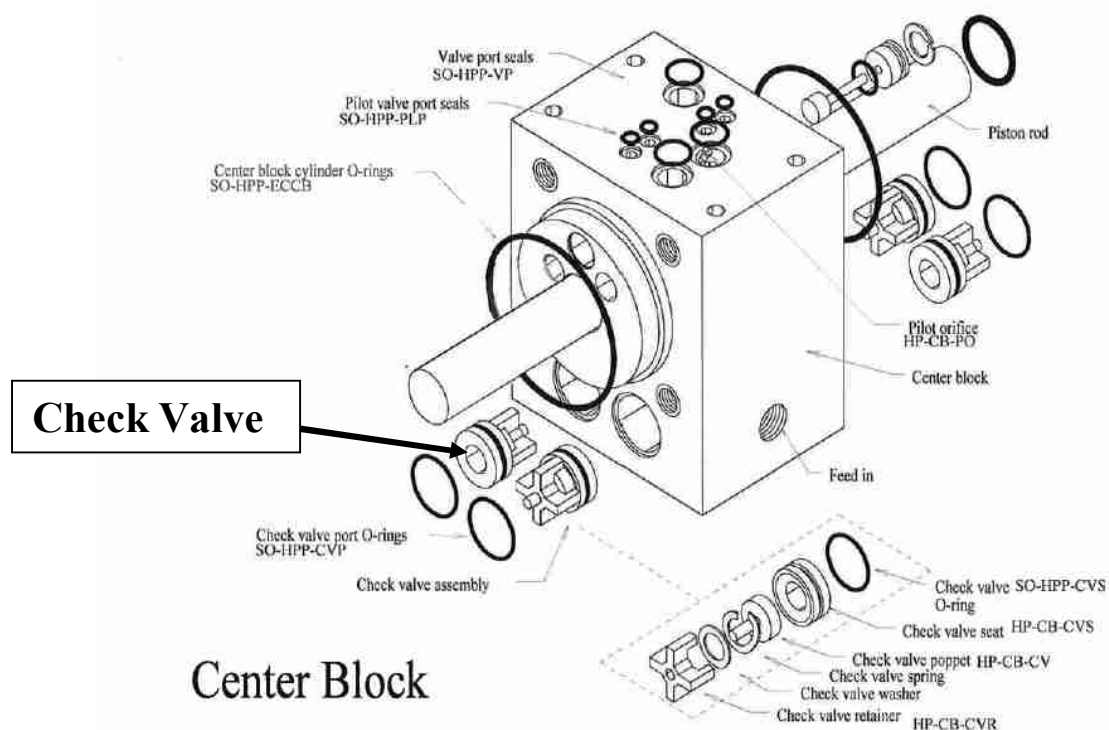
Note that the drawing below shows the valves pulled out of the Center Block, they will both be in place when you remove the Cylinder. One check valve will have a round hole showing (the one on the left in the picture below) and you will be able to see the head of the white valve when you look inside. You can clean this valve with a q-tip or something similar. The other valve will need to be pulled out to clean it. Grab the retainer with a pair of needle nose pliers and pull it out, it's a press fit, but it will come out easily. The valve components are likely to come apart but it is easy to reassemble and install. Clean both the inside of the hole where you removed the valve and all the individual parts. Reassemble the valve retainer, washer, spring, valve poppet and carefully grab the end of the white shaft where it comes out of the valve retainer and push the valve back into place. Check to insure you cannot see the end of the spring poking out around the washer; if you can repeat the above process. If the Spring is not installed correctly the valve will not work. Replace the o-rings if required and reassemble everything.

If your Clark pump suddenly has pressure only on one stroke it is typically a small piece of debris in one of the check valves, which causes it to leak. This typically happens on a new install due to a small piece of Teflon tape getting stuck in the valve or after a filter change where a small piece of debris gets into the Clark Pump.

Inspecting the Check Valves for debris requires you remove the Cylinder from the base, which usually means removing the Clark pump from its mounting bracket. Note that the cylinders are full of water so be prepared. Once you can remove the cylinder assembly, which will come off in one piece, there are three o-rings that seal this part; a large Center Block o-ring and the two smaller o-rings for the check valve ports. It is quite common for all three of these o-rings to stay in place when the Cylinder is removed.
